TELEDYNE CONTINENTAL[®] AIRCRAFT ENGINE
CRITICAL SERVICE BULLETIN
 Compliance Necessary To Maintain Safety

CATEGORY 2
CSB96-1
 FAA APPROVED

SUBJECT: STARTER GEAR AND CLUTCH ASSEMBLY P/N 653575

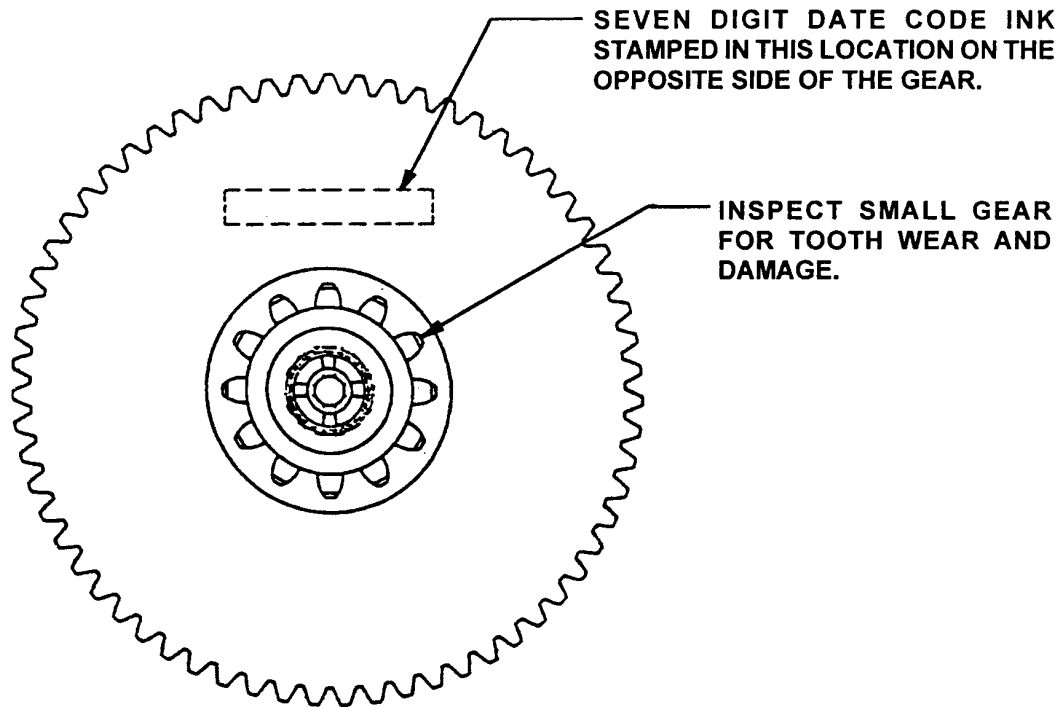
FIGURE 1. P/N 653575 GEAR AND CLUTCH ASSEMBLY

PURPOSE: TCM Quality Control has identified certain starter gear and clutch assemblies (P/N 653575) manufactured by Consolidated Fuel Systems Incorporated that may not meet heat treating specifications.

1. Inspect the rear side of the large gear (see Figure 1) and verify the seven digit date code number. Assemblies identified with the date codes listed in Table 1 or any assemblies that do not have a visible date code may contain improperly heat treated gears and must be returned to a TCM Distributor for replacement.

2. Remove the starter assembly attaching hardware and carefully remove the starter and the gear and clutch assembly from the accessory case.
3. Reference Figure 1. Inspect the small gear for tooth wear or damage. If the gear teeth exhibit wear or damage, contact your local TCM Field Service Representative or TCM Factory Customer Service at (334) 438-3411 for additional instructions.

- A. Affected engine models that have had P/N 653575 starter gear and clutch assemblies installed and accumulated LESS than 25 hours in service must be removed and inspected for an affected date code listed in Table 1. If the assembly is identified with an affected date code or does not have a visible date code, return the assembly to a TCM Distributor for replacement.

4. Gear and clutch assemblies that do not exhibit tooth wear or damage may continue in service.
5. Install the serviceable or a replacement gear and clutch assembly and the starter. Install starter assembly attaching hardware. Torque nuts (3 each) to 180-220 in/lbs. Torque bolts (two each) to 155-175 in/lbs.
