service bulletin

M83-3

SUBJECT: ROTO MASTER (Rajay) SERVICE LETTER 27 REVISION A DATED
SEPTEMBER 24, 1982 AND ADDENDUM THERETO DATED FEBRUARY 9,
1983 IN RESPONSE TO FAA AD 82-07-03.

SUBJECT: Rajay Turbocharger Model 325E10 Inspection of Turbocharger Turbine Housings P/N TC-60-11 and/or 600510-01, 600510-02.

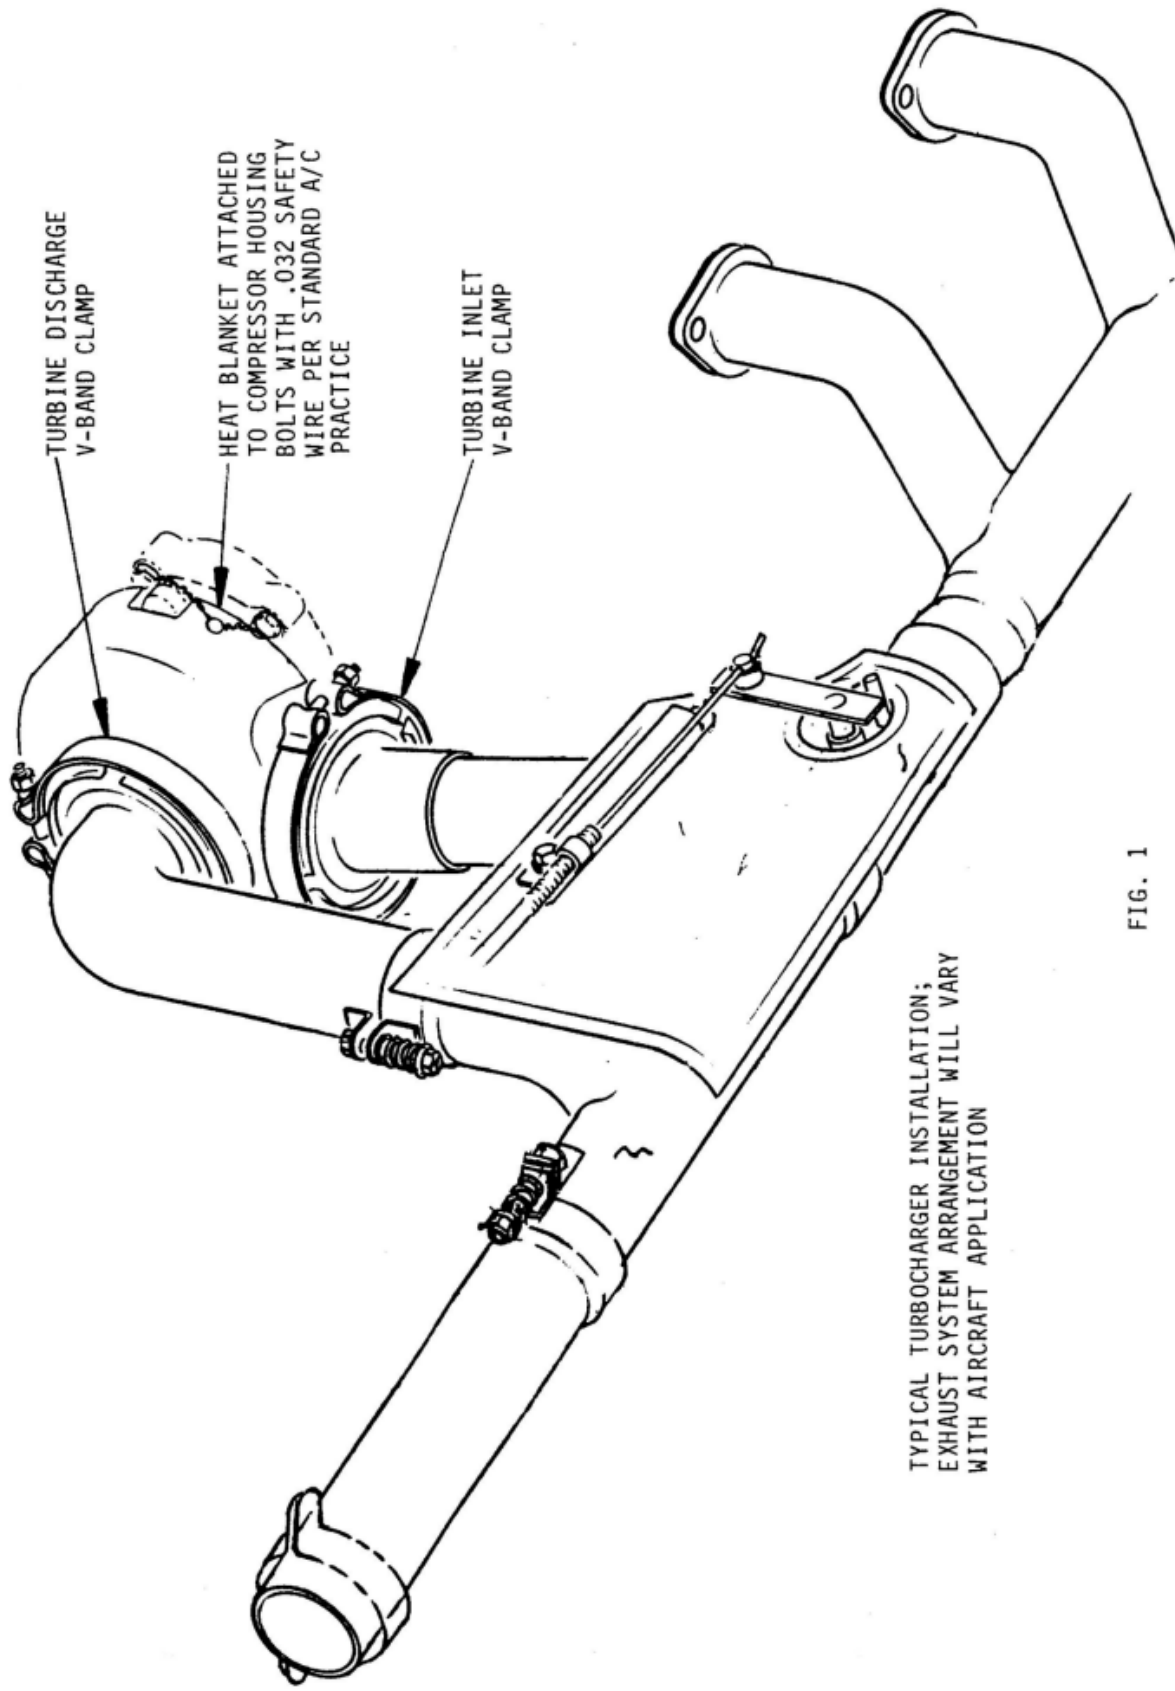
FIG. 1

TYPICAL TURBOCHARGER INSTALLATION;
EXHAUST SYSTEM ARRANGEMENT WILL VARY
WITH AIRCRAFT APPLICATION

In certain aircraft installations, it may be possible to inspect the turbine housing inner and outer walls for penetrating cracks per Views 1 and 3, without removal of the turbocharger from the aircraft. In any event, the exhaust manifold must be disconnected from the coupling V-band so that the turbine housing internal area near the nozzle can be seen as shown in View 2. If a thermal blanket is installed on the turbine housing, it must be removed. (See Figure 1.)

1. Remove the turbine housing blanket (if installed). (See Figure 1.)
2. Disconnect the exhaust manifold by removing the coupling V-bands.
3. Make "index marks" on the turbine housing and on the aluminum bearing housing so the turbine housing will be reinstalled in the same correct rotational position.
4. Remove the V-band nut and carefully remove the bearing housing V-band (P/N 600391).
5. Remove the turbine housing from the bearing housing and inspect per Description A.1. and 2. Light tapping at the joint with a rawhide mallet will help separate them.
6. While the housing is off, inspect the turbine wheel and heat shield for condition and/or foreign object damage.

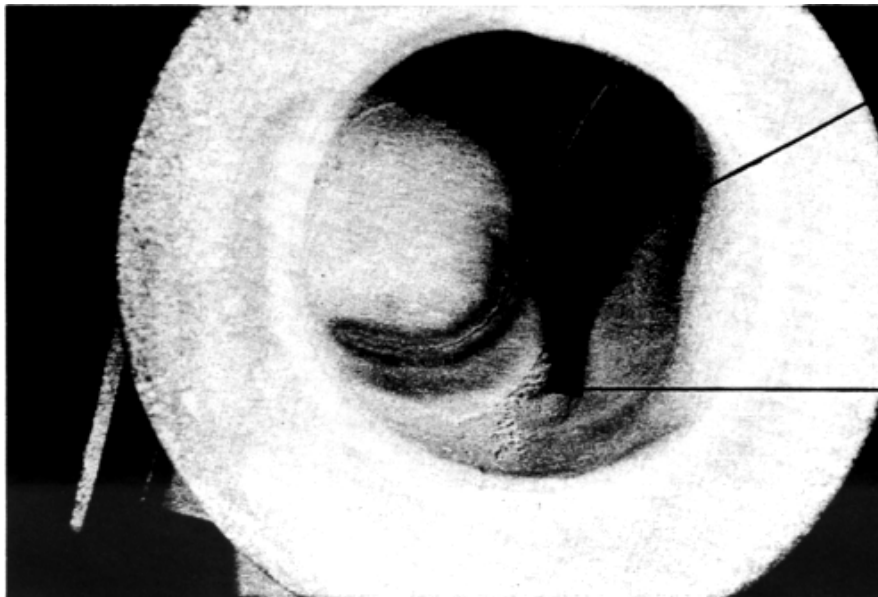
VIEW 1 Turbine Housing Exhaust Inlet Internal Cracks.

Formation of hairline cracks has been discovered in the inlet area of the turbocharger turbine housing (Rajay part number TC-60-11 or 600510-02) used on Model 325E10 Rajay turbochargers in production since June 1976. In some cases, the crack in the above referenced area (tongue area) may have propagated through the outer wall of the turbine housing.

INTERNAL CRACK

Cracks in this area are allowable to a length of .75 inch maximum.

Do not misrepresent the casting parting line in this area as a crack.

1. Inspection of Turbocharger Installed on Engine - After the initial 50 hours Turbocharger time-in-service operation and/or at next aircraft annual and/or 100 hours inspection, whichever occurs first, and thereafter at every 200 hours unit time-in-service, but not later than May 31, 1983. Visually inspect the Turbocharger turbine housing to ascertain possible presence of cracks penetrating the outer wall as shown in View 3.
 - a. If Outer Wall Is Penetrated - Replace the turbine housing and gasket with a new P/N 600510-04 (TCM P/N 643931**) housing and new P/N 600400-00 (TC-6-30) (TCM P/N 643932**) gasket prior to the next flight.
2. Inspection of Turbocharger Removed from Engine - Visually inspect the turbocharger turbine housing through the exhaust port for presence of cracks as shown in View 1.

- a. If No Cracks Are Found - on the inner or outer wall of the turbine housing, reinstall turbocharger, and at the 200 hours time-in-service repeat the inspection of the unit per A.1. above
- b. If An Internal Crack Is Found - remove turbine housing and inspect for cracks as shown in View 3.
 - (1) If All Internal Cracks are found within the limits of Views 1, 2 and 3, then the turbine housing may be returned to service, but continue to monitor the crack propagation at next and subsequent 200 hours time-in-service.
 - (2) If An Internal Crack Exceeds The Limit - as shown in Views 1, 2 or 3, then the turbine housing and gasket must be replaced with new housing as specified in A. 1.a above.

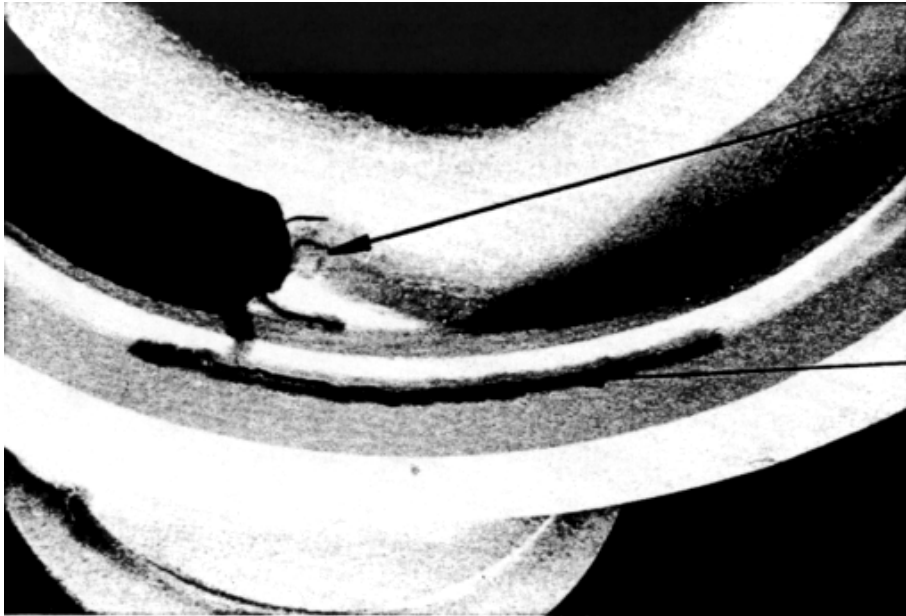
VIEW 2 View of Turbine Housing with turbo center section removed.

Cracks in this area allowable to 3/4 inch.

Cracks in this area allowable to 2 inches.

To inspect the turbine housing for internal cracks per View 2, remove the complete turbocharger from the aircraft as per aircraft maintenance manual.
