service bulletin

M90-13
Technical Portions Are
FAA Approved

16 July 1990

SUBJECT: **EXHAUST VALVE STEM CORROSION/EROSION**

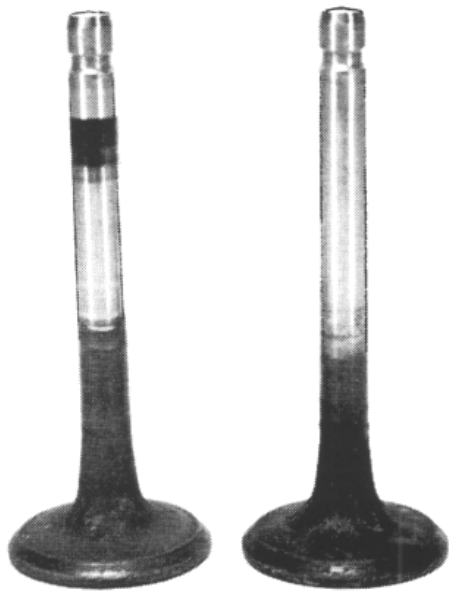
Figure 1.
Normal Wear

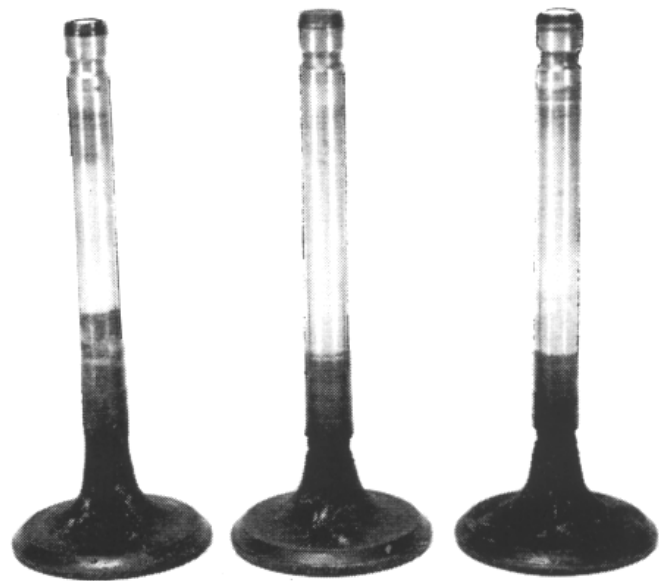
TCM cylinders are equipped with solid stem exhaust valves made of an exotic alloy, Nimonic 80A. Service history of these valves has been excellent and unparalleled in the industry. TCM Service Bulletin M87-11 recommends 100% replacement at overhaul due to stem wear and/or stem to head corrosion/erosion, or pitting. TCM has become aware that occasionally this condition has progressed at the time of overhaul to the extreme example shown in Figure 2, which undetected could lead to valve failure.

Figure 2.
Excessive Corrosion/Erosion

Laboratory tests conducted by the valve manufacturer have shown the condition is caused by chemicals that exist in the exhaust gases while the valves are at operating temperature. The source of the chemicals is a product of combustion of the fuels and oils being used; however, we have not established any correlation between the valve environment of an operating engine and the stem corrosion that resulted in laboratory tests.

It is strongly recommended, therefore, that at any time cylinder/exhaust system maintenance is performed prior to major overhaul, the exhaust valves be examined through the exhaust port for excessive corrosion/erosion or pitting in the head to stem area. If a stem diameter reduction of 10% or more is evident, replacement should be considered prior to major overhaul.
