MANDATORY SERVICE BULLETIN

MSB11-4B

SUBJECT: STARTER ADAPTER INSPECTION

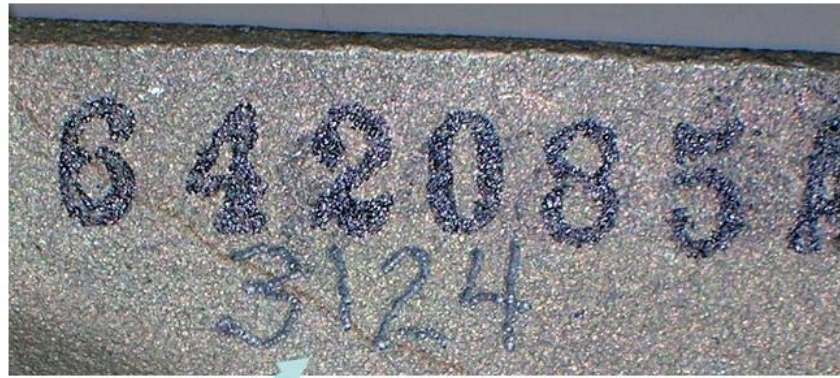
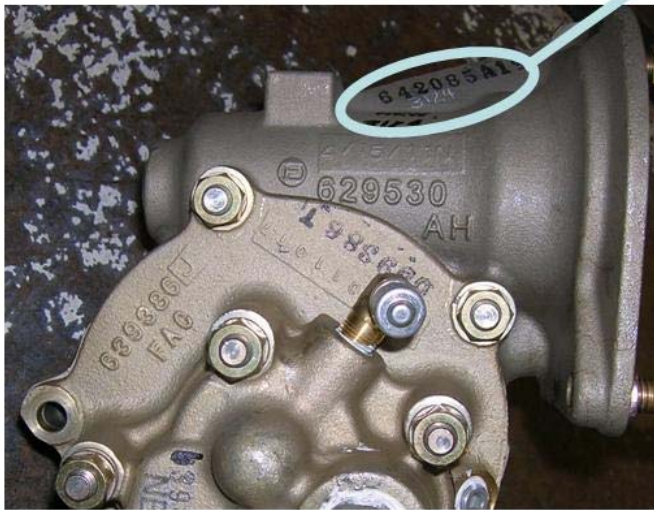
FIGURE 1. Example of Vibro-Peened Manufacturer Code

Replacement compliant starter adapters are identified by a vibro-peened manufacturer code below the ink stamped starter adapter part number as depicted below. See FIGURE 1 on page 5.

Replacement starter adapters that incorporate assembly corrective action are identified by a vibro-peened manufacturer code below the ink stamped starter adapter part number as depicted below. See Figure 1 on page 5.

New and rebuilt compliant starter adapters supplied by Continental Motors Inc (CMI) are identifiable by a vibro-peened manufacturer code below the ink stamped assembly part number, example of 4 digit code is shown in FIGURE 1.
