# CONTINENTAL MOTORS<sup>®</sup> AIRCRAFT ENGINE SERVICE BULLETIN

SUBJECT:	Inspection and Replacement of IO240 Starter and Crankshaft Cluster Gear FAA APPROVED
PURPOSE:	To notify owners, operators, maintenance facilities and distributors of inspection, repair and/or replacement of starter assembly, starter motor, drive clutch assembly and crankshaft cluster gear.
COMPLIANCE:	Initial inspection at starter removal, no later than the next scheduled inspection. A recurring service inspection of the crankshaft cluster gear is required at every starter removal.
MODELS AFFECTED:	All IO240 and IOF240B series engines.

ISSUED	REVISED	CONTINENTAL CONTINENTAL 8	PAGE NO	DOC NO	REVISION
2014/09/16		P.O. Box 90 Mobile, AL 251-436-8299	1 of 8	SB14-2

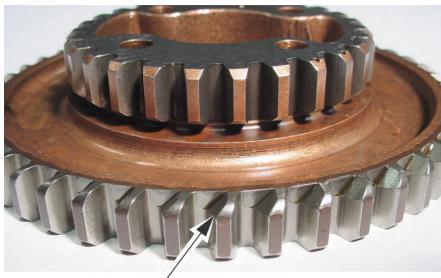
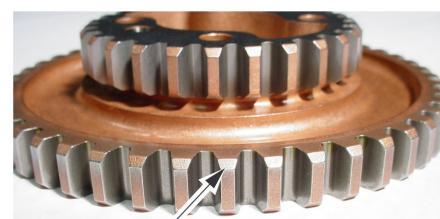
Figure 4. Chamfer Tooth Gear Profile

- 1. Ensure that the ignition switch is OFF, the magnetos are grounded, and starter assembly is removed (see Section III, "Removal Instructions").
- 2. With the starter assembly removed, use a flashlight (or appropriate supplemental lighting) to visually inspect the crankshaft cluster gear through the starter assembly mounting hole in the rear of the accessory case.
- 3. Determine the gear tooth profile of the installed crankshaft cluster gear (as shown in Figure 4). Incompatible (straight tooth) gear profiles must be replaced.

- 4. Identify the crankshaft cluster gear part number to determine if replacement is required. Any incompatible cluster gear must be replaced using the procedures contained in the IO240/ IOF240B Engine Maintenance and Overhaul Manuals (M-6/M-22):

- a. If replacing starter assembly P/Ns 654046, 655551, 655957 (B & C starter P/N BC320-1), 657375, or 634464 with starter assembly 658291; replace crankshaft cluster gear with crankshaft cluster gear 656072.

- b. If the crankshaft cluster gear cannot be properly identified, replace with starter assembly P/N 658291 and crankshaft cluster gear 656072.
- 5. Examine the wear criteria on the larger of the two gears to determine either acceptable wear (Figure 5) or unacceptable wear (Figure 6) to the crankshaft cluster gear (see steps 5., a. and b.). After completely inspecting the visible gear tooth surfaces for wear, slowly rotate the engine crankshaft to examine the next section of the gear until all gear tooth surfaces have been completely inspected and the wear patterns have been reviewed against the following criteria:

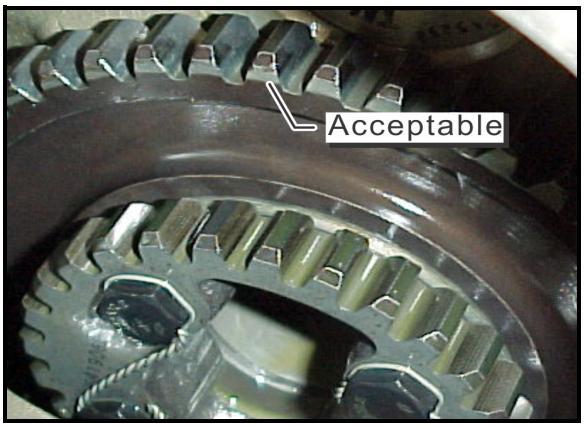
Figure 5. Acceptable Wear Criteria

- a. Acceptable Wear Figure 5 depicts normal wear patterns for the crankshaft cluster gear. This wear pattern is normal and should not be confused with damaged gear teeth as shown in Figure 6.
  - 1) Visible signs of polishing to the contact surfaces of the larger gear teeth that receive initial contact from the pinion gear during start.
  - 2) The wear should be generally even and consistent around the entire circumference of the gear.

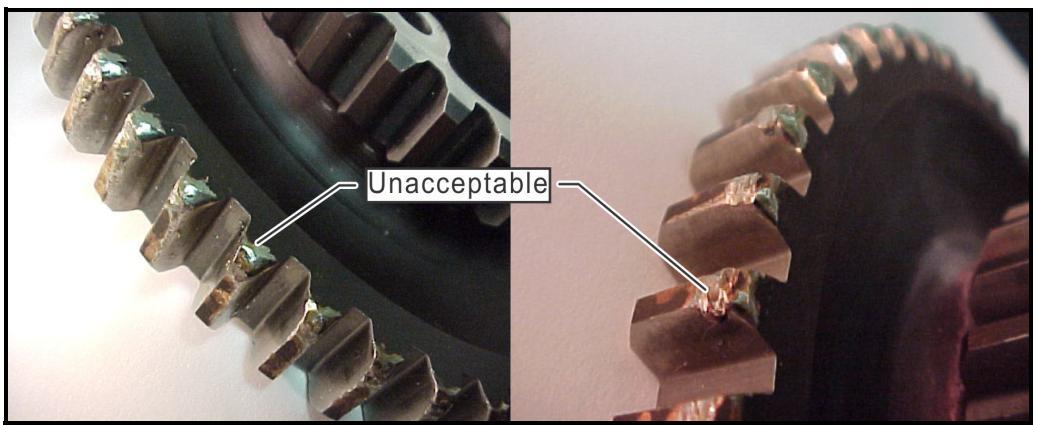
Figure 6. Unacceptable Wear Criteria

- b. Unacceptable Wear Figure 6 depicts unacceptable or abnormal wear of a crankshaft cluster gear.
  - 1) There will be extremely rough areas with damage to the tooth surfaces and the surrounding gear areas.
  - 2) In some circumstances portions of teeth may be broken away from the gear. The most extreme cases may have whole teeth missing.
  - 3) If the damage is considered abnormal **without** complete teeth missing, replace the crankshaft cluster gear in accordance with the instructions contained in the applicable sections of the IO240/IOF240B Maintenance and Overhaul Manuals (M-6/M-22).
  - 4) If the crankshaft cluster gear is missing one or more complete teeth, please contact Continental Motors Customer Service Department directly at 1(800) 326-0089.
