# CONTINENTAL MOTORS<sup>®</sup> AIRCRAFT ENGINE SERVICE BULLETIN

SUBJECT:	Inspection and Replacement of IO240 Starter and Crankshaft Cluster Gear FAA APPROVED
PURPOSE:	To notify owners, operators, maintenance facilities and distributors of inspection, repair and/or replacement of starter assembly, starter motor, drive clutch assembly and crankshaft cluster gear.
COMPLIANCE:	Initial inspection at starter removal, no later than the next scheduled inspection. A recurring service inspection of the crankshaft cluster gear is required at every starter removal.
MODELS AFFECTED:	All IO240 and IOF240B series engines.

ISSUED	REVISED	CONTINENTAL CONTINENTAL 8	PAGE NO	DOC NO	REVISION
2014/09/16		P.O. Box 90 Mobile, AL 251-436-8299	1 of 8	SB14-2

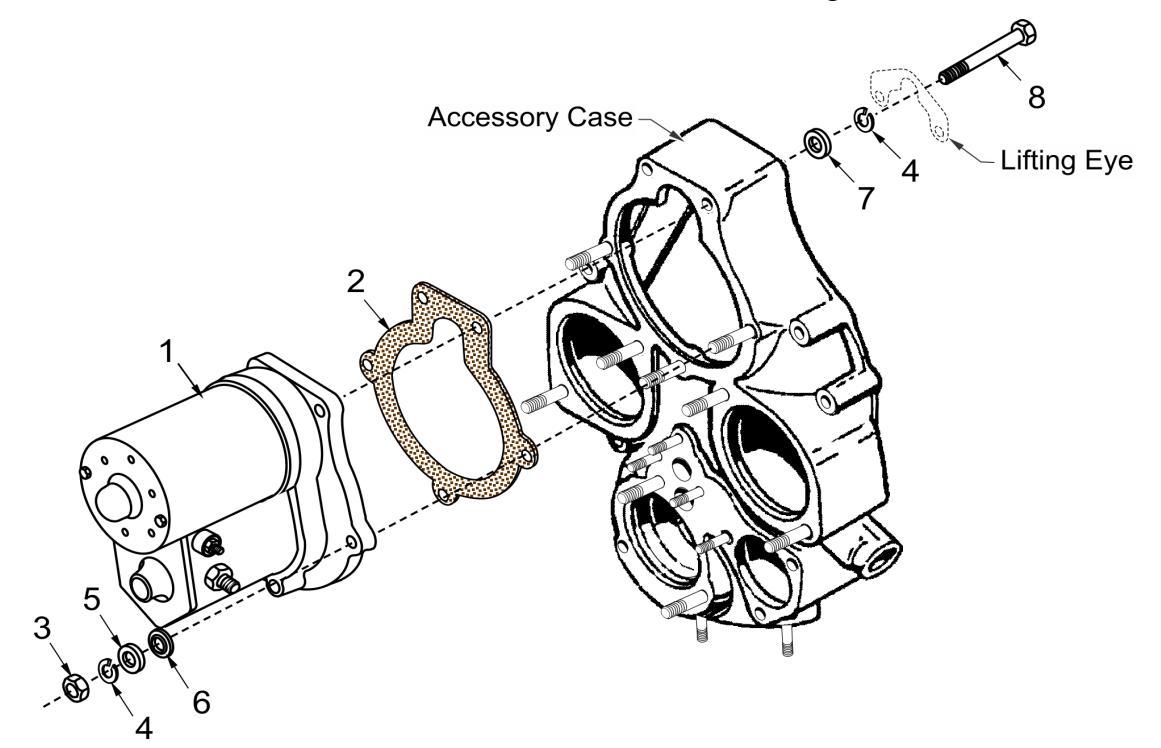
- 1. Remove attaching washers, spacers, and nuts (Figure 1, items 3, 4, 5 & 6). Discard washers and spacers.
- 2. Remove bolts (8), lifting eye, and washers (4 & 7), from starter drive assembly housing (1) and accessory case. Replace bolts P/N 538999 with new bolts P/N 630966-4.00 (8) if removing the P/N 634464 starter motor and P/Ns 641500 or 653575 clutch assembly. Retain lifting eye and discard washers.
- 3. Lightly tap/bump the starter (1) by hand to break the starter gasket (2) adhesion. Carefully remove the starter and clutch, if installed, and discard the starter gasket.
